INSPECTION REPORT

For the Property at:
Your New Home
Your Town , AB T1M 1H3

Prepared for: Home Buyer and Home Buyer
Inspection Date: Friday, November 11, 2016
Prepared by: Bryan Henschel License 343554

RE: Report No. 1097

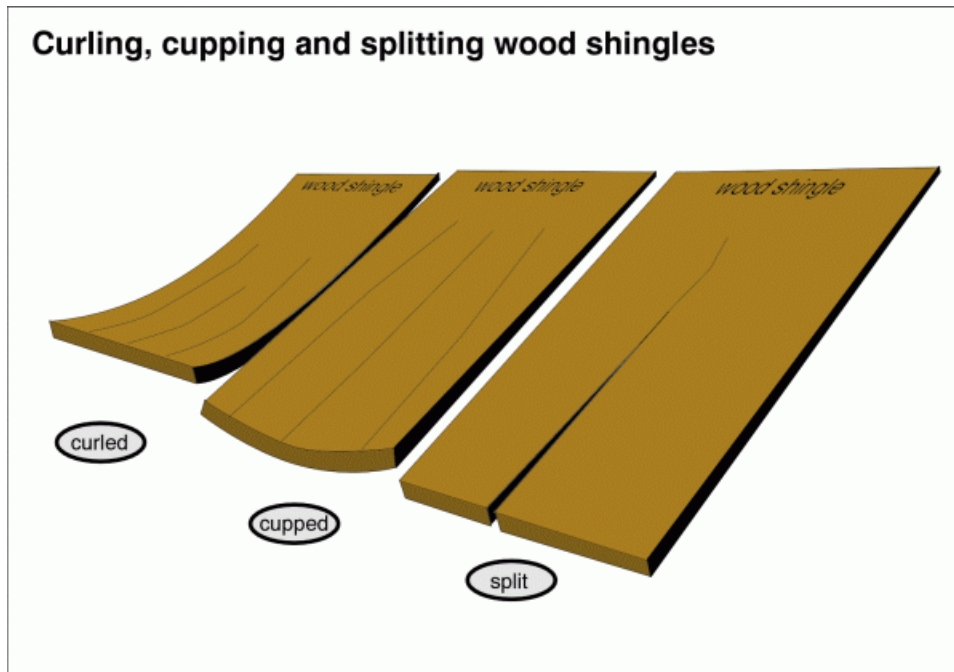
1. **Condition:** • [Cupping, curling](#)

Implication(s): Chance of water damage to contents, finishes and/or structure

Location: Throughout Exterior Roof

Curling, cupping and splitting wood shingles

Task: Replace

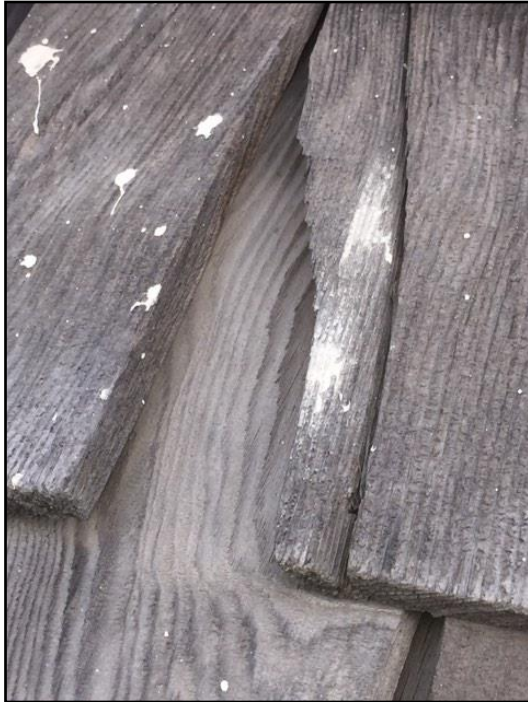
3. *Damaged, broken or missing pieces*

3. Condition: • [Damaged, broken or missing pieces](#)

Implication(s): Chance of water damage to contents, finishes and/or structure

Task: Replace

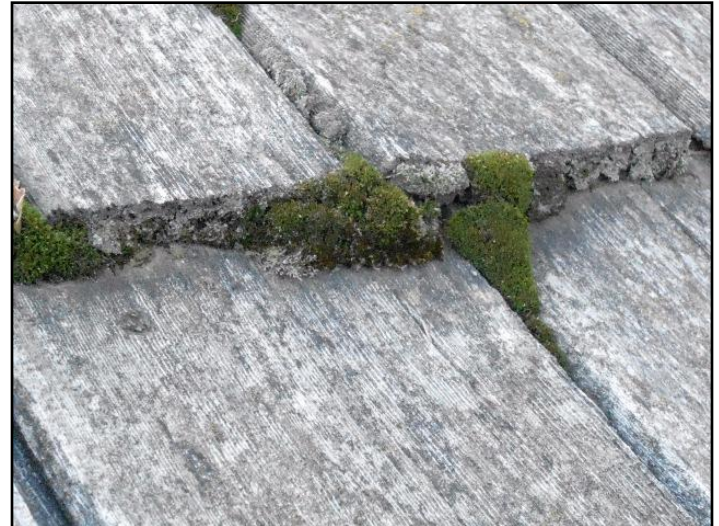
6. Moss, mildew, etc.

4. **Condition:** • [Moss, mildew, etc.](#)

Implication(s): Chance of water damage to contents, finishes and/or structure

Location: Throughout Exterior Roof

Task: Clean

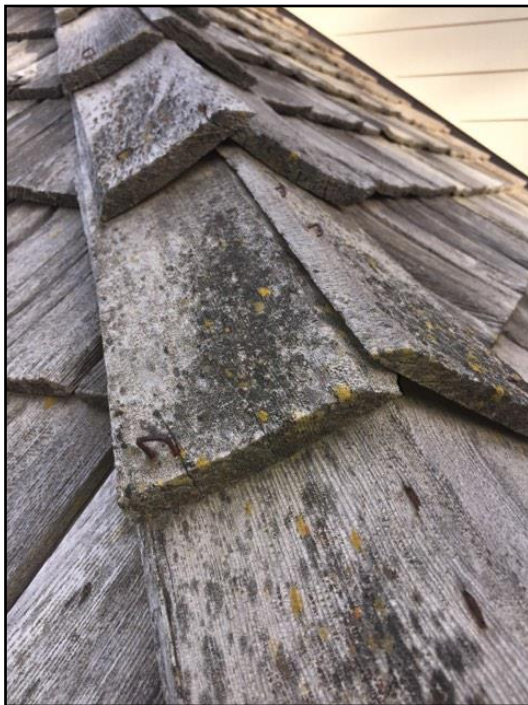
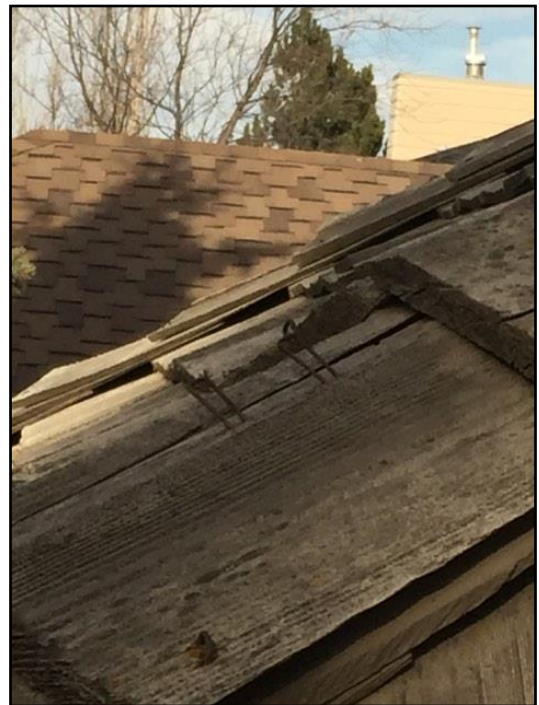
5. **Condition:** • [Staples](#)

Implication(s): Reduced system life expectancy

8. Staples

9. Staples

Task: Correct

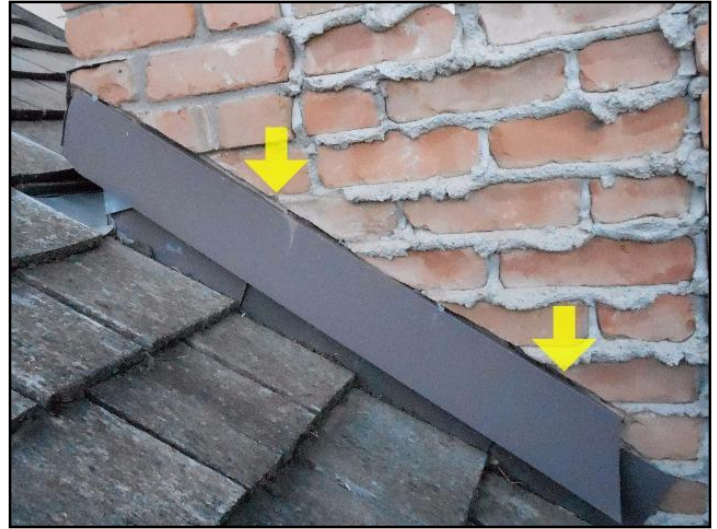
6. • Recommend sealant to reduce chance of moisture untrusion

Task: Regular Maintenance Item

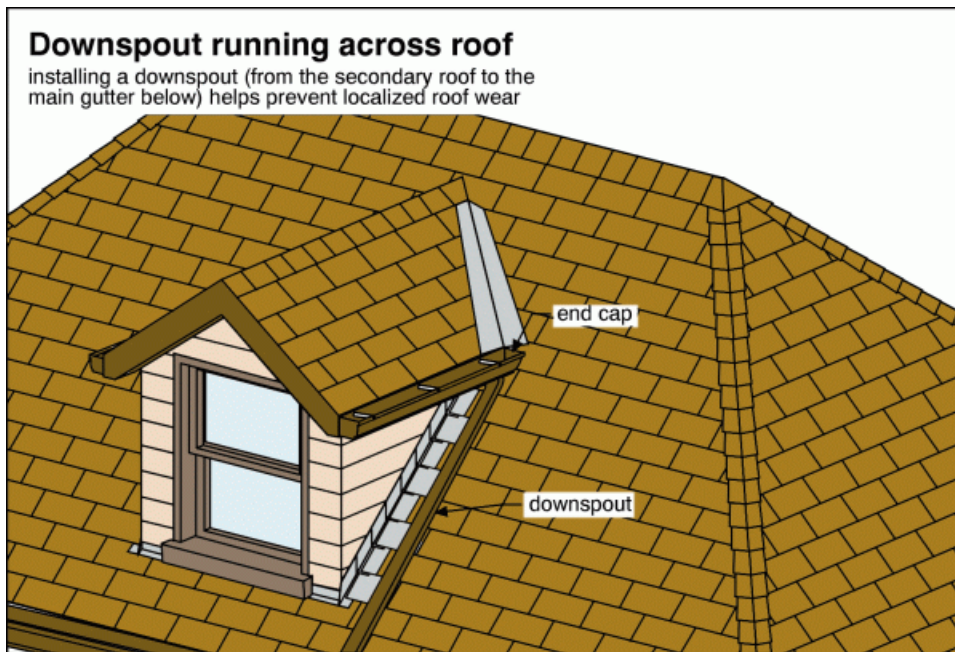
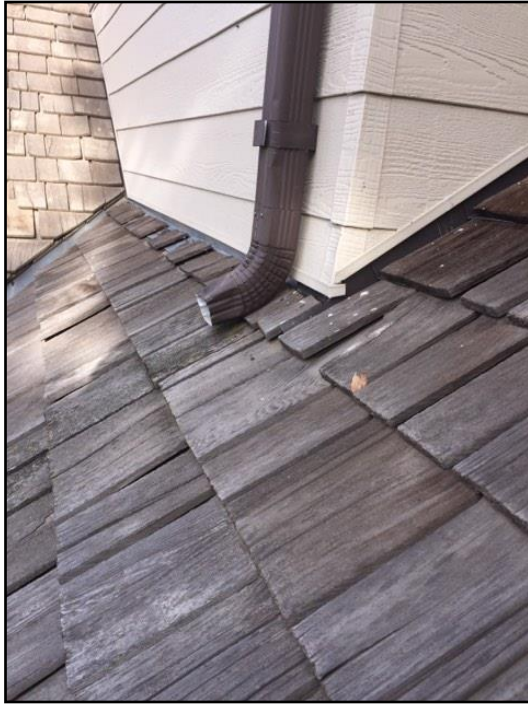
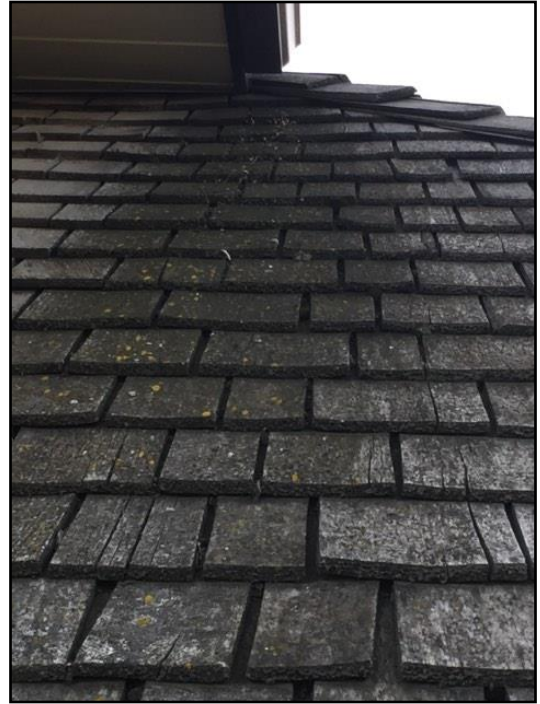
7. Condition: • [Downspouts discharging onto roofs](#)

Gutters discharging onto the roof surface is a common building practice. We recommend directing the water directly to another gutter to avoid areas of shortened life expectancy.

Implication(s): Chance of water damage to contents, finishes and/or structure

23. *Downspouts discharging onto roofs*

24. *Downspouts discharging onto roofs*

Task: Preventative maintenance item

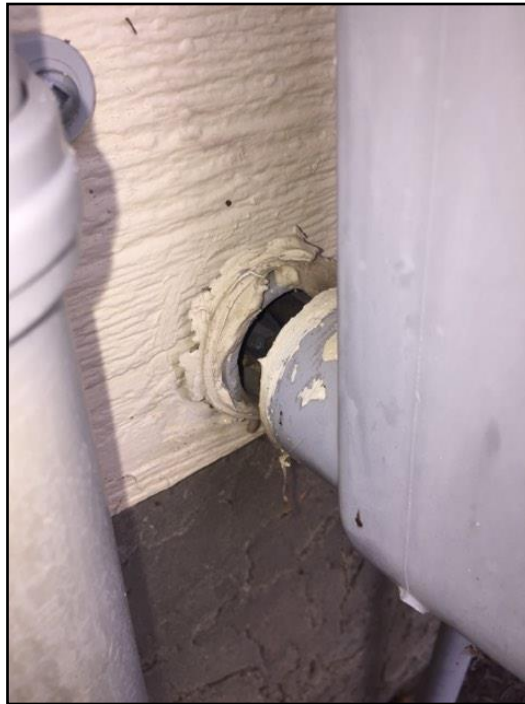
10. Condition: • [Conduit or cable damaged](#)

Chance of moisture or pests entering the property

38. Conduit or cable damaged

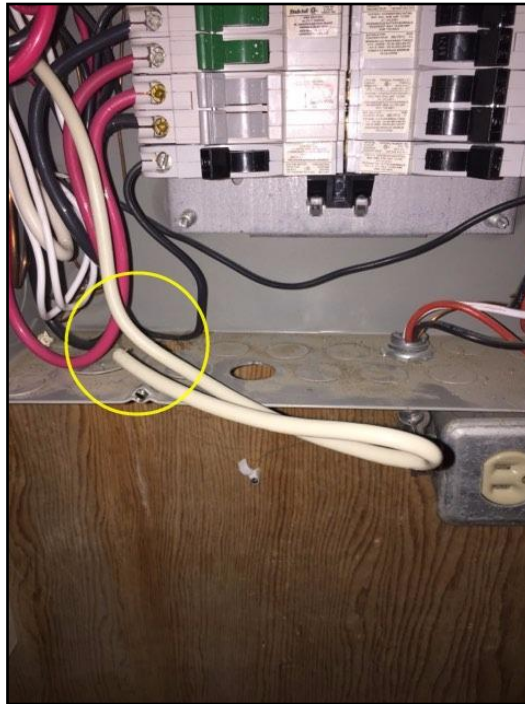
11. Condition: • [Abandoned wires in panel](#)

39. Abandoned wires in panel

Task: Recommend further evaluation by qualified electrician

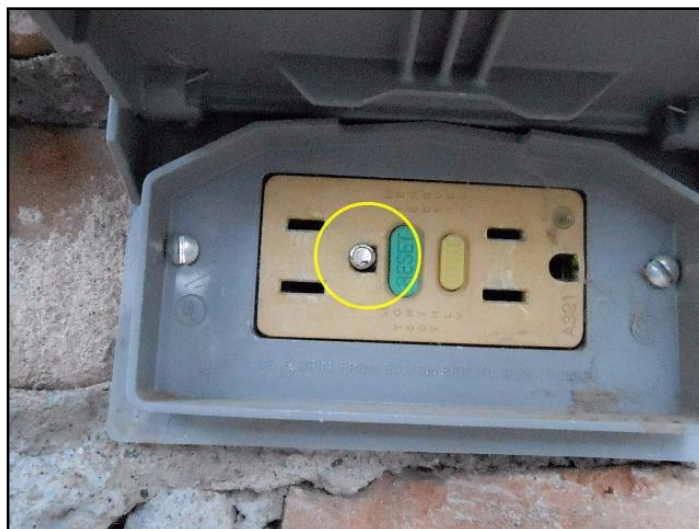
12. Condition: • [Broken pin or blade in slots](#)

Implication(s): Equipment failure | Electric shock

40. Broken pin or blade in slots

Task: Replace

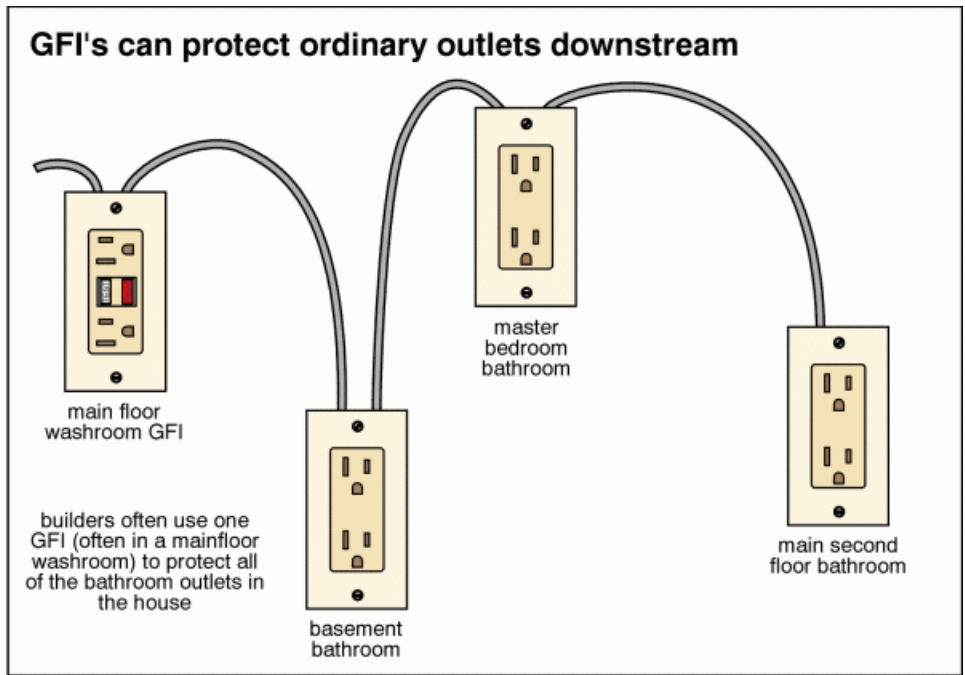
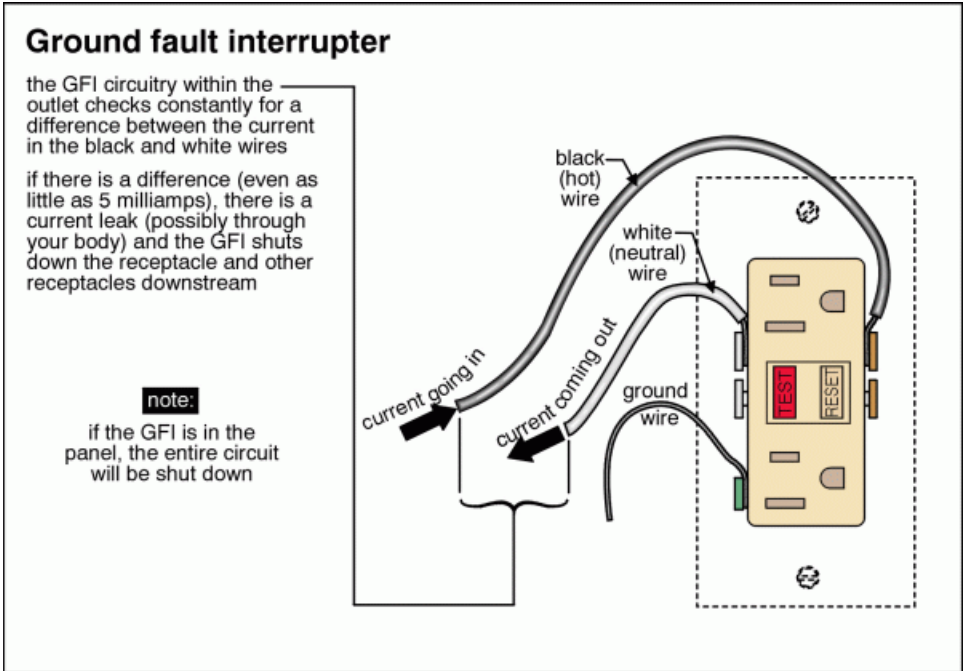
13. Condition: • [No GFCI \(Ground Fault Circuit Interrupter\)](#)

Although not required. GFI protection is recommended for all wet areas of the home

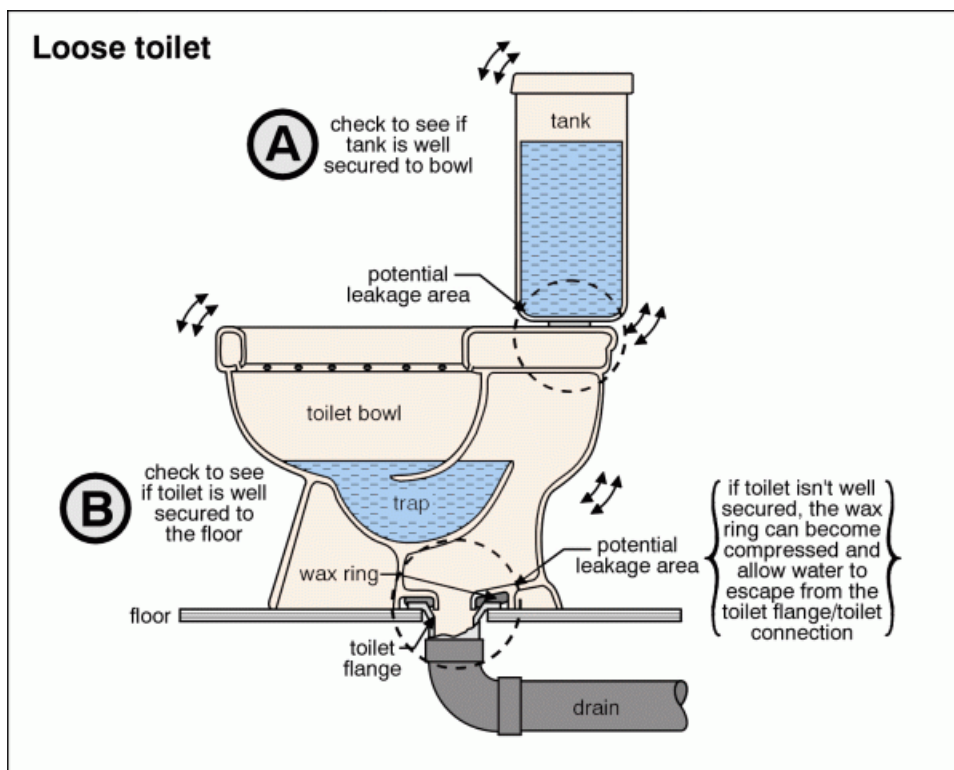
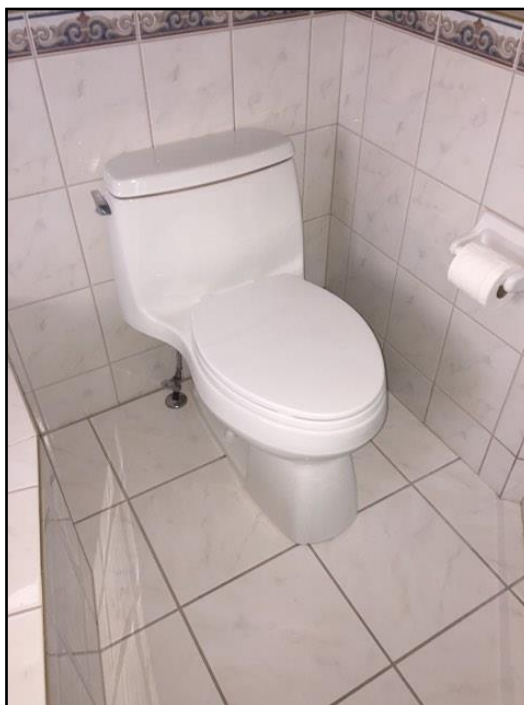
17. Condition: • [Loose](#)

Implication(s): Chance of water damage to contents, finishes and/or structure | Sewage entering the building

52. *Loose*

Task: Correct

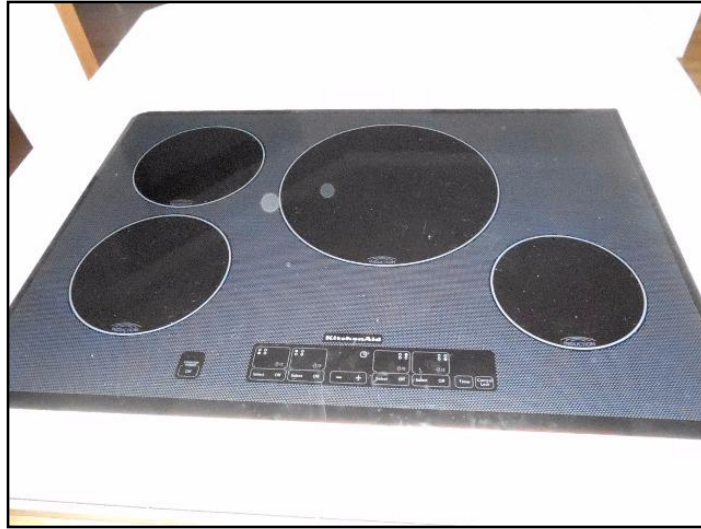
61.

18. • Could not get cook top to operate properly at time of inspection. Recommend asking current home owner to demonstrate proper operation of the appliance

Task: Request disclosure

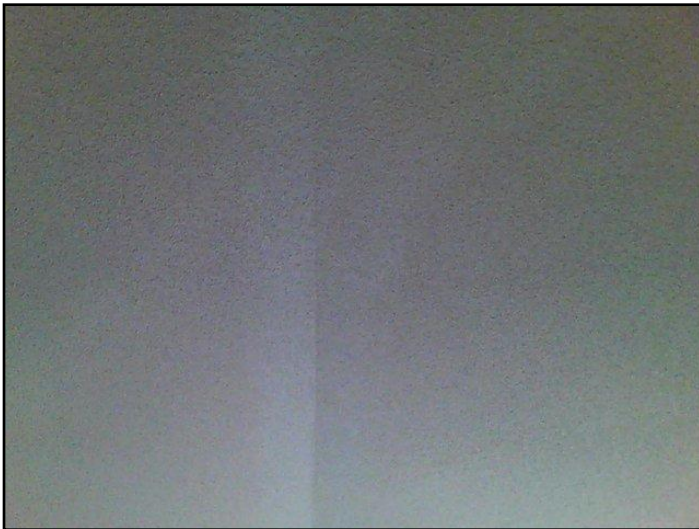
62.

19. Condition: • Signs of previous repair, Thermal imaging showed no indication of excess moisture at time of inspection

Location: First Floor Living Room, Kitchen

Task: Request disclosure

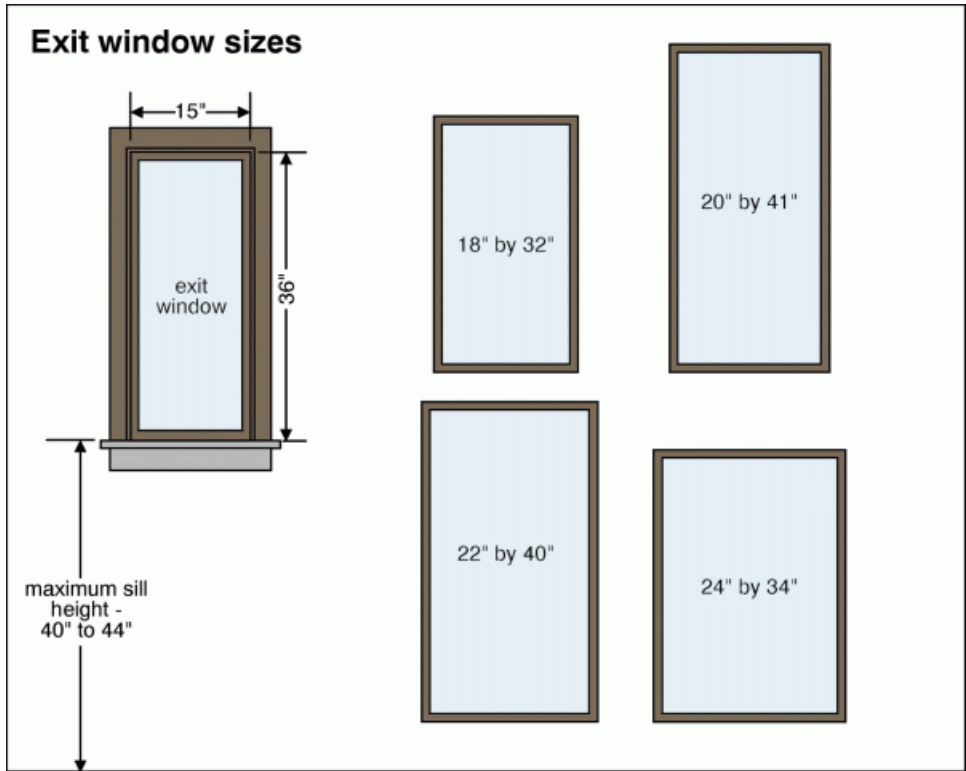
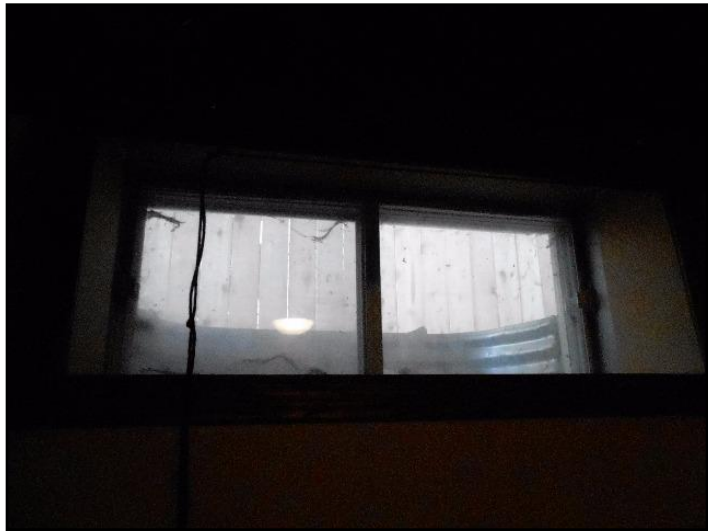
21. Condition: • [Too small](#)

Location: Basement Bedroom

66. Too small

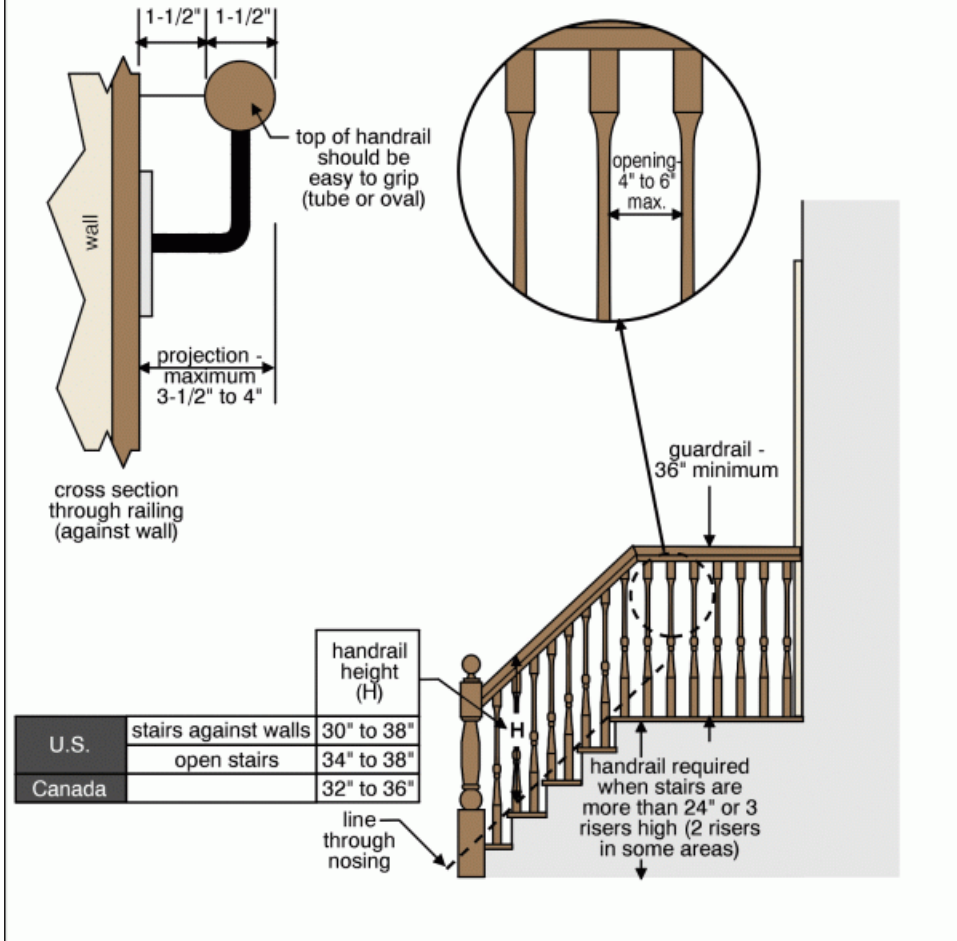
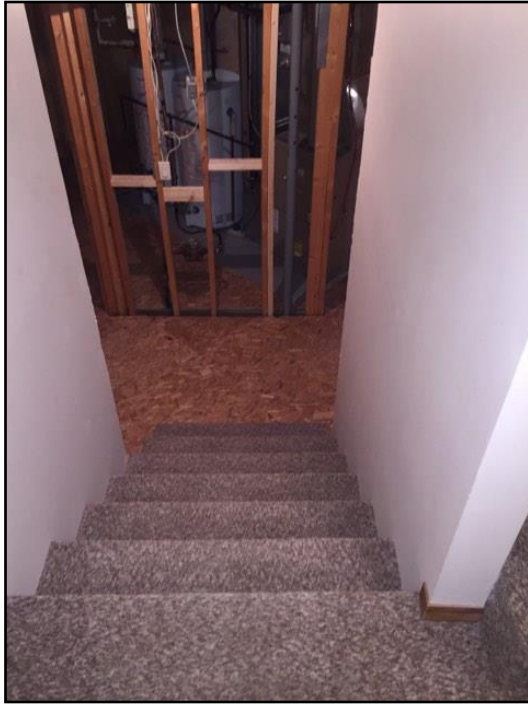
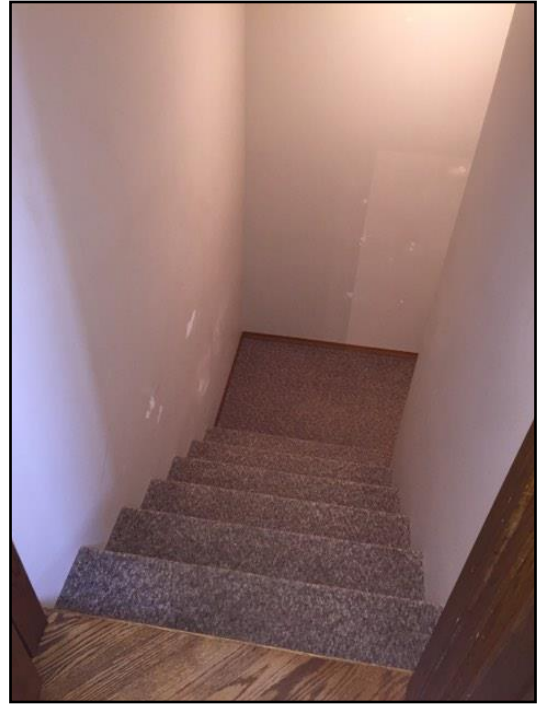
22. Condition: • [Missing](#)

Implication(s): Fall hazard

67. Missing

68. Missing
