INSPECTION REPORT

For the Property at:
Your New Home
Your Town , AB T1M 1H3

Prepared for: Home Buyer and Home Buyer
Inspection Date: Friday, November 11, 2016
Prepared by: Bryan Henschel License 343554

RE: Report No. 1097

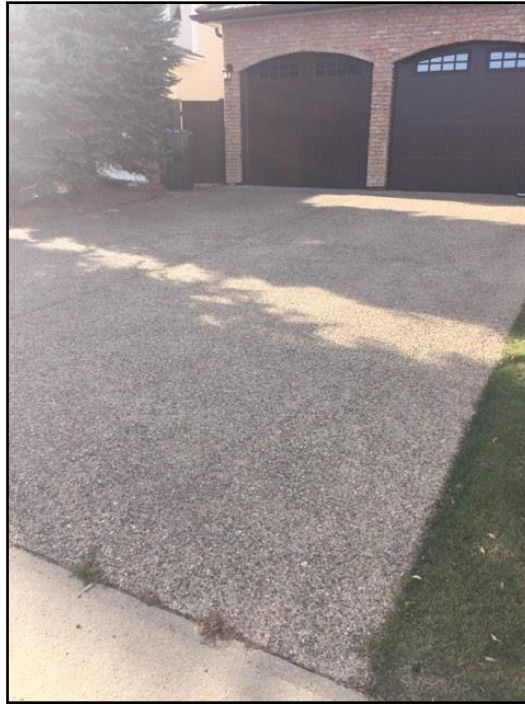
13. Concrete

- No performance issues were noted.

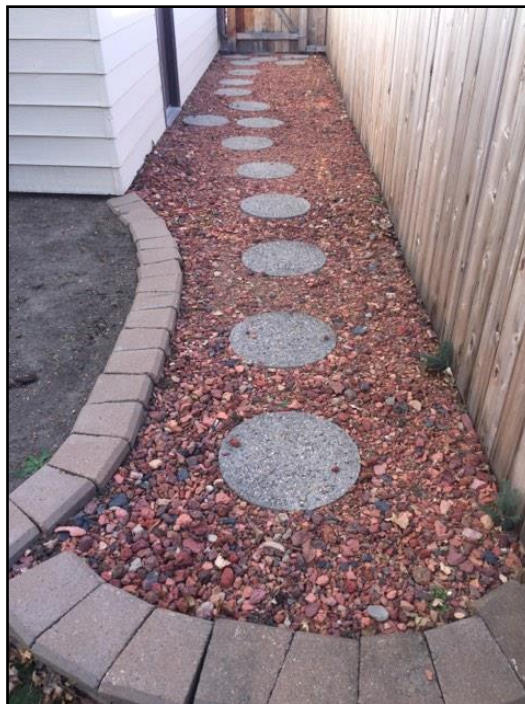
15. Patio stones

- No performance issues were noted.

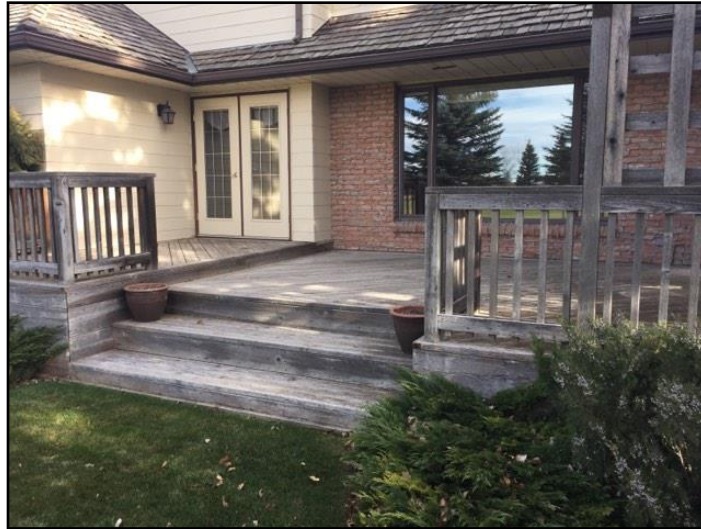
16. *Raised*

- Wood
- No performance issues were noted

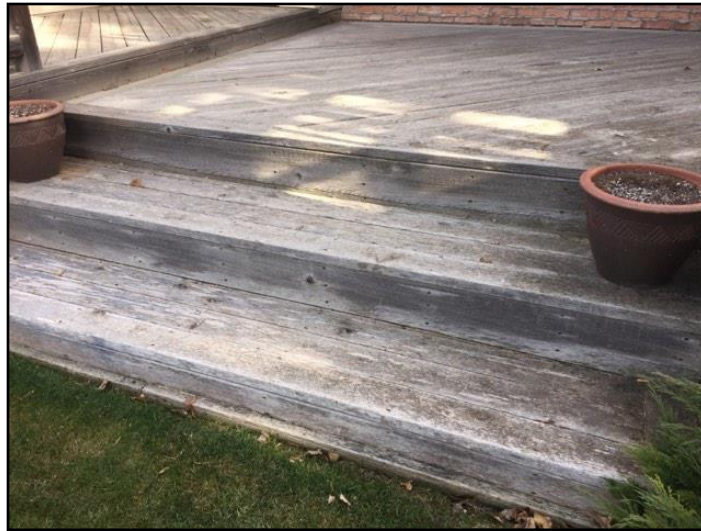
18. *Wood*

- No performance issues were noted.

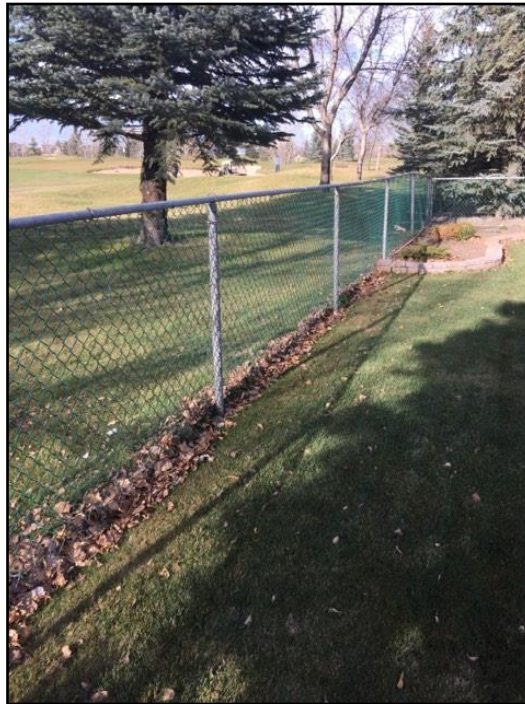
20. Chain link

- No performance issues were noted.

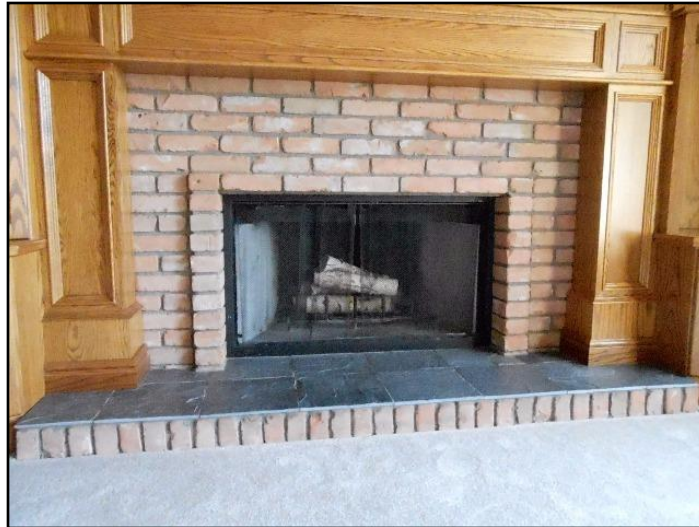
43. Wood-burning fireplace

14. **Condition:** • [Inspect \(and/sweep if needed\) before using](#)

Implication(s): Fire hazard

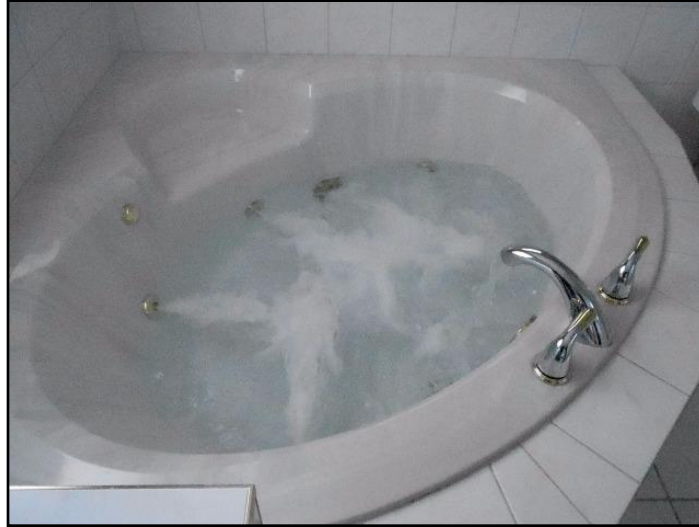
48. Jetted Bathtub

General: • Jetted Bath tested and performed as expected

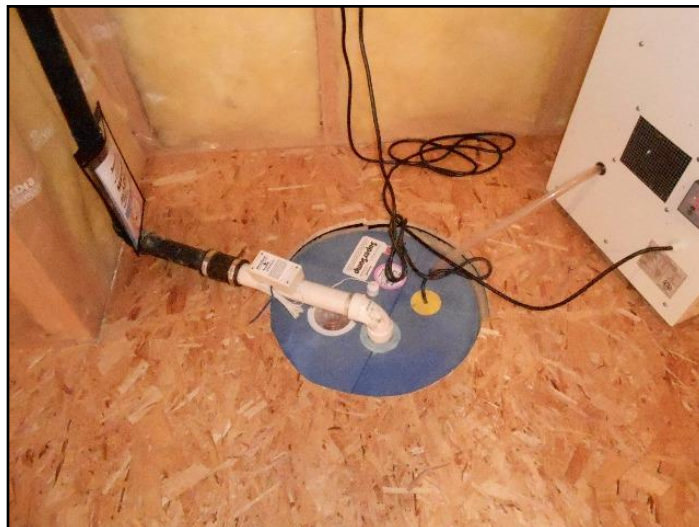
51. Sump pump

Tested and worked as expected

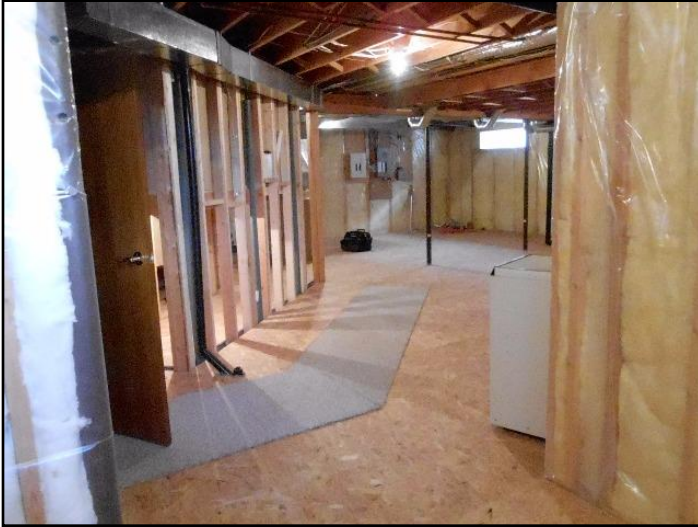
53. Basement

General: • Basement under current development
